MEMORANDUM

Understanding of the Hydraulic Nature of the Northwest Fault

PUMP TEST - FAULT SIDE (BRAQUET)

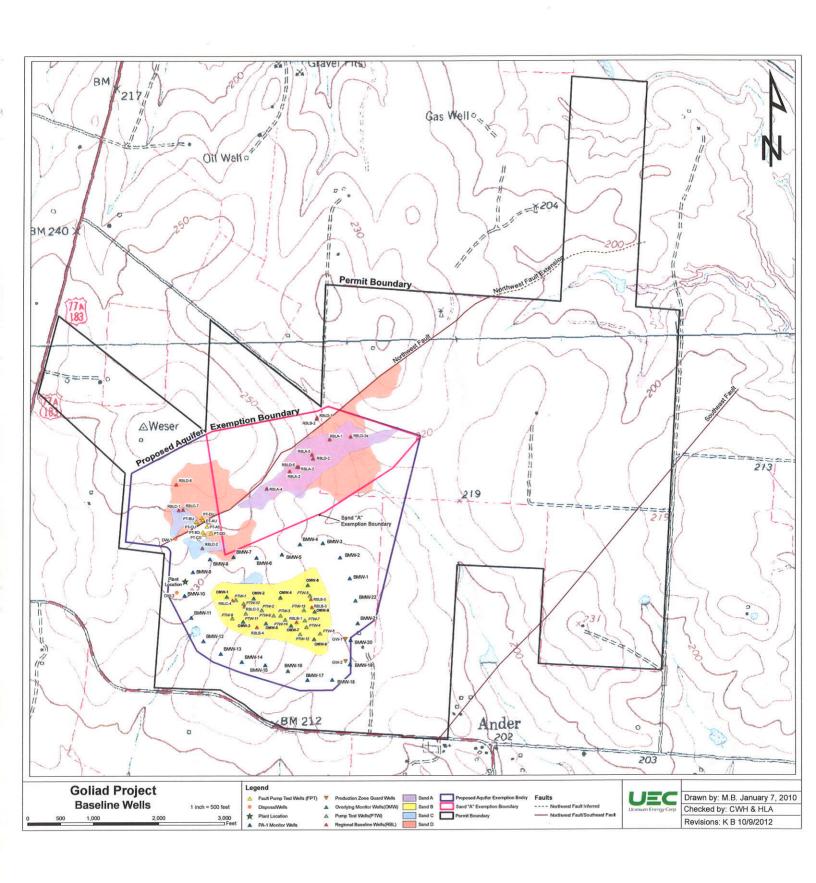
In an effort to improve their understanding of the hydrogeology and nature of the Northwest Fault, UEC performed three four-hour interference pump tests and three 24-hour interference pump tests to characterize the hydraulic connection across the Northwest Fault. These tests are draft in form and were not required to meet regulatory requirements at the site. However, these tests corroborate other geologic and hydrogeologic data in providing evidence that the Northwest Fault acts as a barrier to groundwater flow locally.

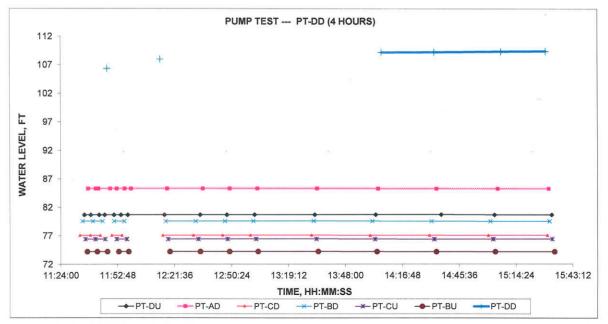
Pump Test - PT-DD

Initial Water Levels:	PT-DD PT-DU PT-BD PT-BU PT-CD PT-CU PT-AD	91.65 80.68 79.53 74.15 77.02 76.37 85.3	PUMPING DURATION AVERAGE FLOWRATE TOTAL NO. OF GALLONS P	FROM	11:35:00 TO 15:19 GPM 3660 GALS	15:36:00 IN HOURS	4:01:00
	PT-AU	55

UEC has performed short-term and longer-term pump tests in the vicinity of the Northwest Fault. A map is enclosed showing the locations of wells. Three independent four-hour pump tests were performed at pumping wells PT-BD, PT-CD and PT-DD, respectively. In each case the wells were pumped at a rate of approximately 15 gallons per minute. All three pumped wells are within the graben. Water levels were monitored and drawdown was calculated for each pumping well and for each PT-series observation well on both sides of the fault. In all three tests, responses both in sands above and below the pumping well within the graben and in all wells across the Northwest Fault outside the graben showed limited drawdown as compared to the pumping well drawdown. Drawdown magnitude in PT wells across the fault ranged from -0.03 ft to 0.07 ft with pumping well drawdowns ranging from 17.8 ft to 64.5 ft. The drawdowns

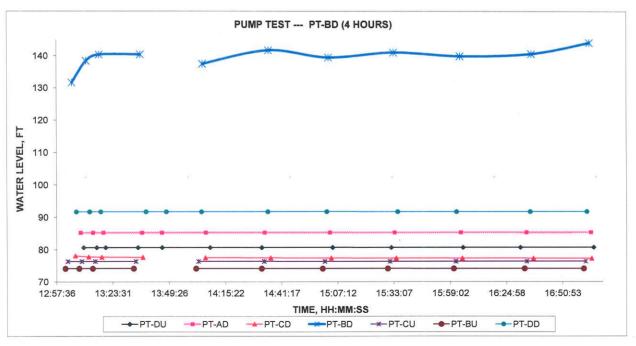
Pump Test - PT-BD

Initial Water Levels: PT-DD PT-DU PT-BD PT-BD PT-BU PT-CD PT-CU PT-AD PT-AD PT-AU	91.65 80.68 79.53 74.15 77.02 76.37 85.3 55	PUMPING DURATION AVERAGE FLOWRATE TOTAL NO. OF GALLONS PUI	FROM	13:00:00 TO 15.16 GPM 3790 GALS	17:10:00 IN HOURS	4:10:00 IN MIN.
---	--	--	------	---------------------------------------	-------------------	-----------------
